Case 330 : Narrative

Case Vehicle (A): 2002 Saturn	Vehicle (B): 2002 Saturn
Type: SL1, 4-door sedan	Type: SL1, 4-door sedan
Driver: 40-year-old female	Driver: 19-year-old female
CDC: 12-FYEW-3, 09-LBEW-1	CDC: 99-0000-0, 99-0000-0

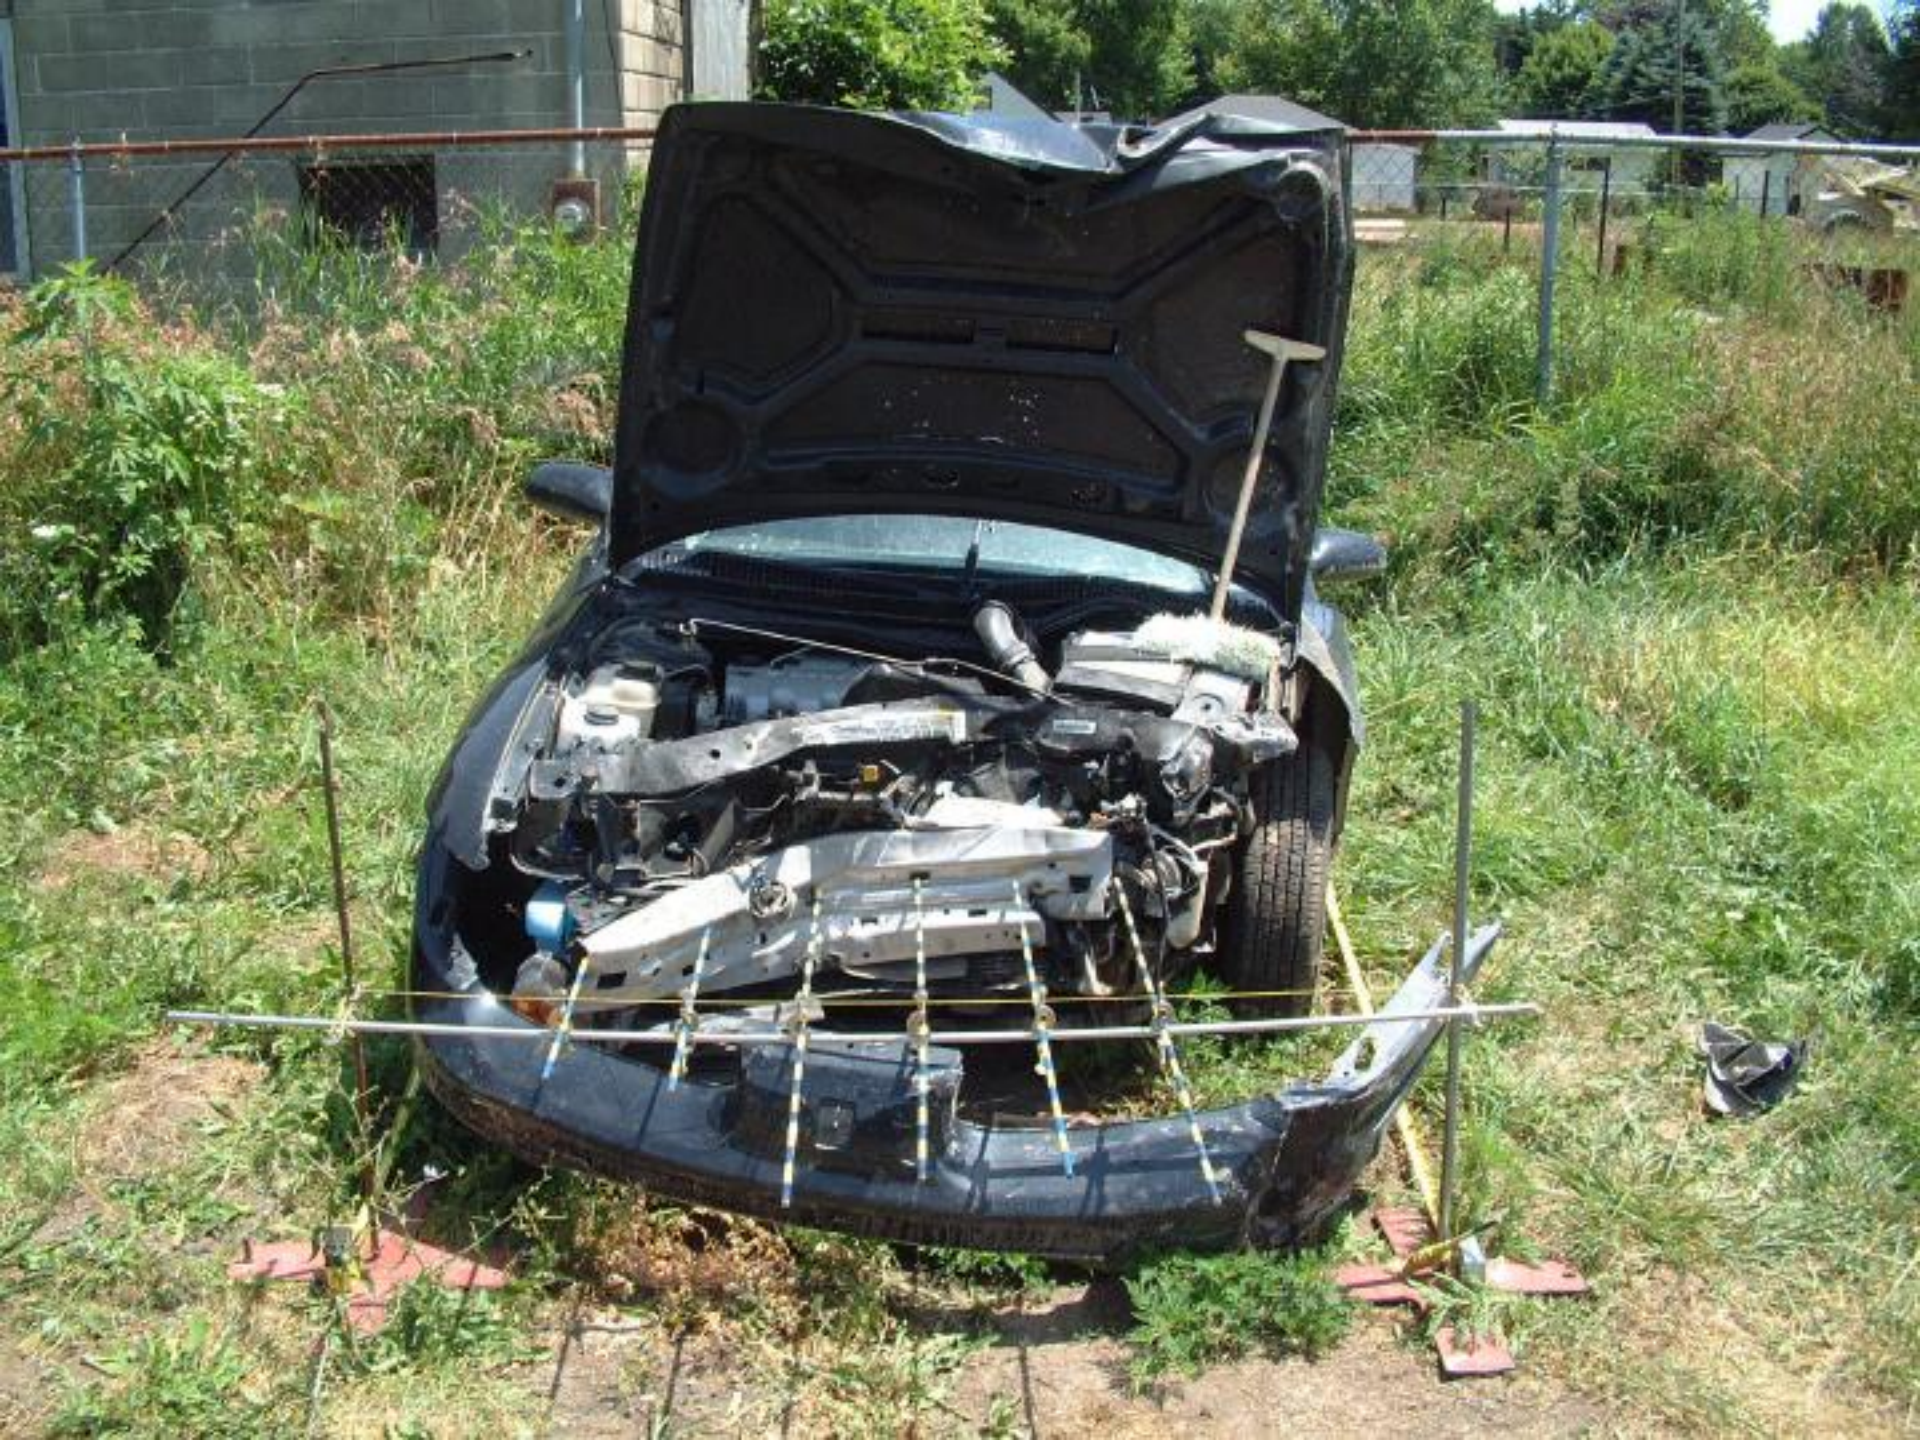
with cloth transfers. [45](#) The windshield was cracked and holed by the rearview mirror when it was broken off at the mounting stalk. [46](#) The rearview mirror was cracked, and [47](#) the back of the right half was scratched with glass embedded in the plastic. [48](#) The vertical console was scuffed and the vertical and center consoles were deflected to the left. The plastic sides of the vertical console were separated and displaced. [49](#) The floor-mounted transmission lever was deflected to the left. [50](#) The right-front sunvisor fabric was scuffed, but it was not damaged. [51](#) The glove compartment door was scuffed and the lower heater/ac duct was broken. [52](#) [53](#) The right-front seatback was deflected forward and [54](#) [55](#) both recliner mechanisms were deflected away from the seat cushion. [56](#) The left side of the rear-seat backrest/luggage area access-panel was down at the time of inspection but had been up at the time of the crash. The following intrusions were noted and measured:

Windshield holed, and cracked, due to contact of rear-view mirror by right-rear passenger

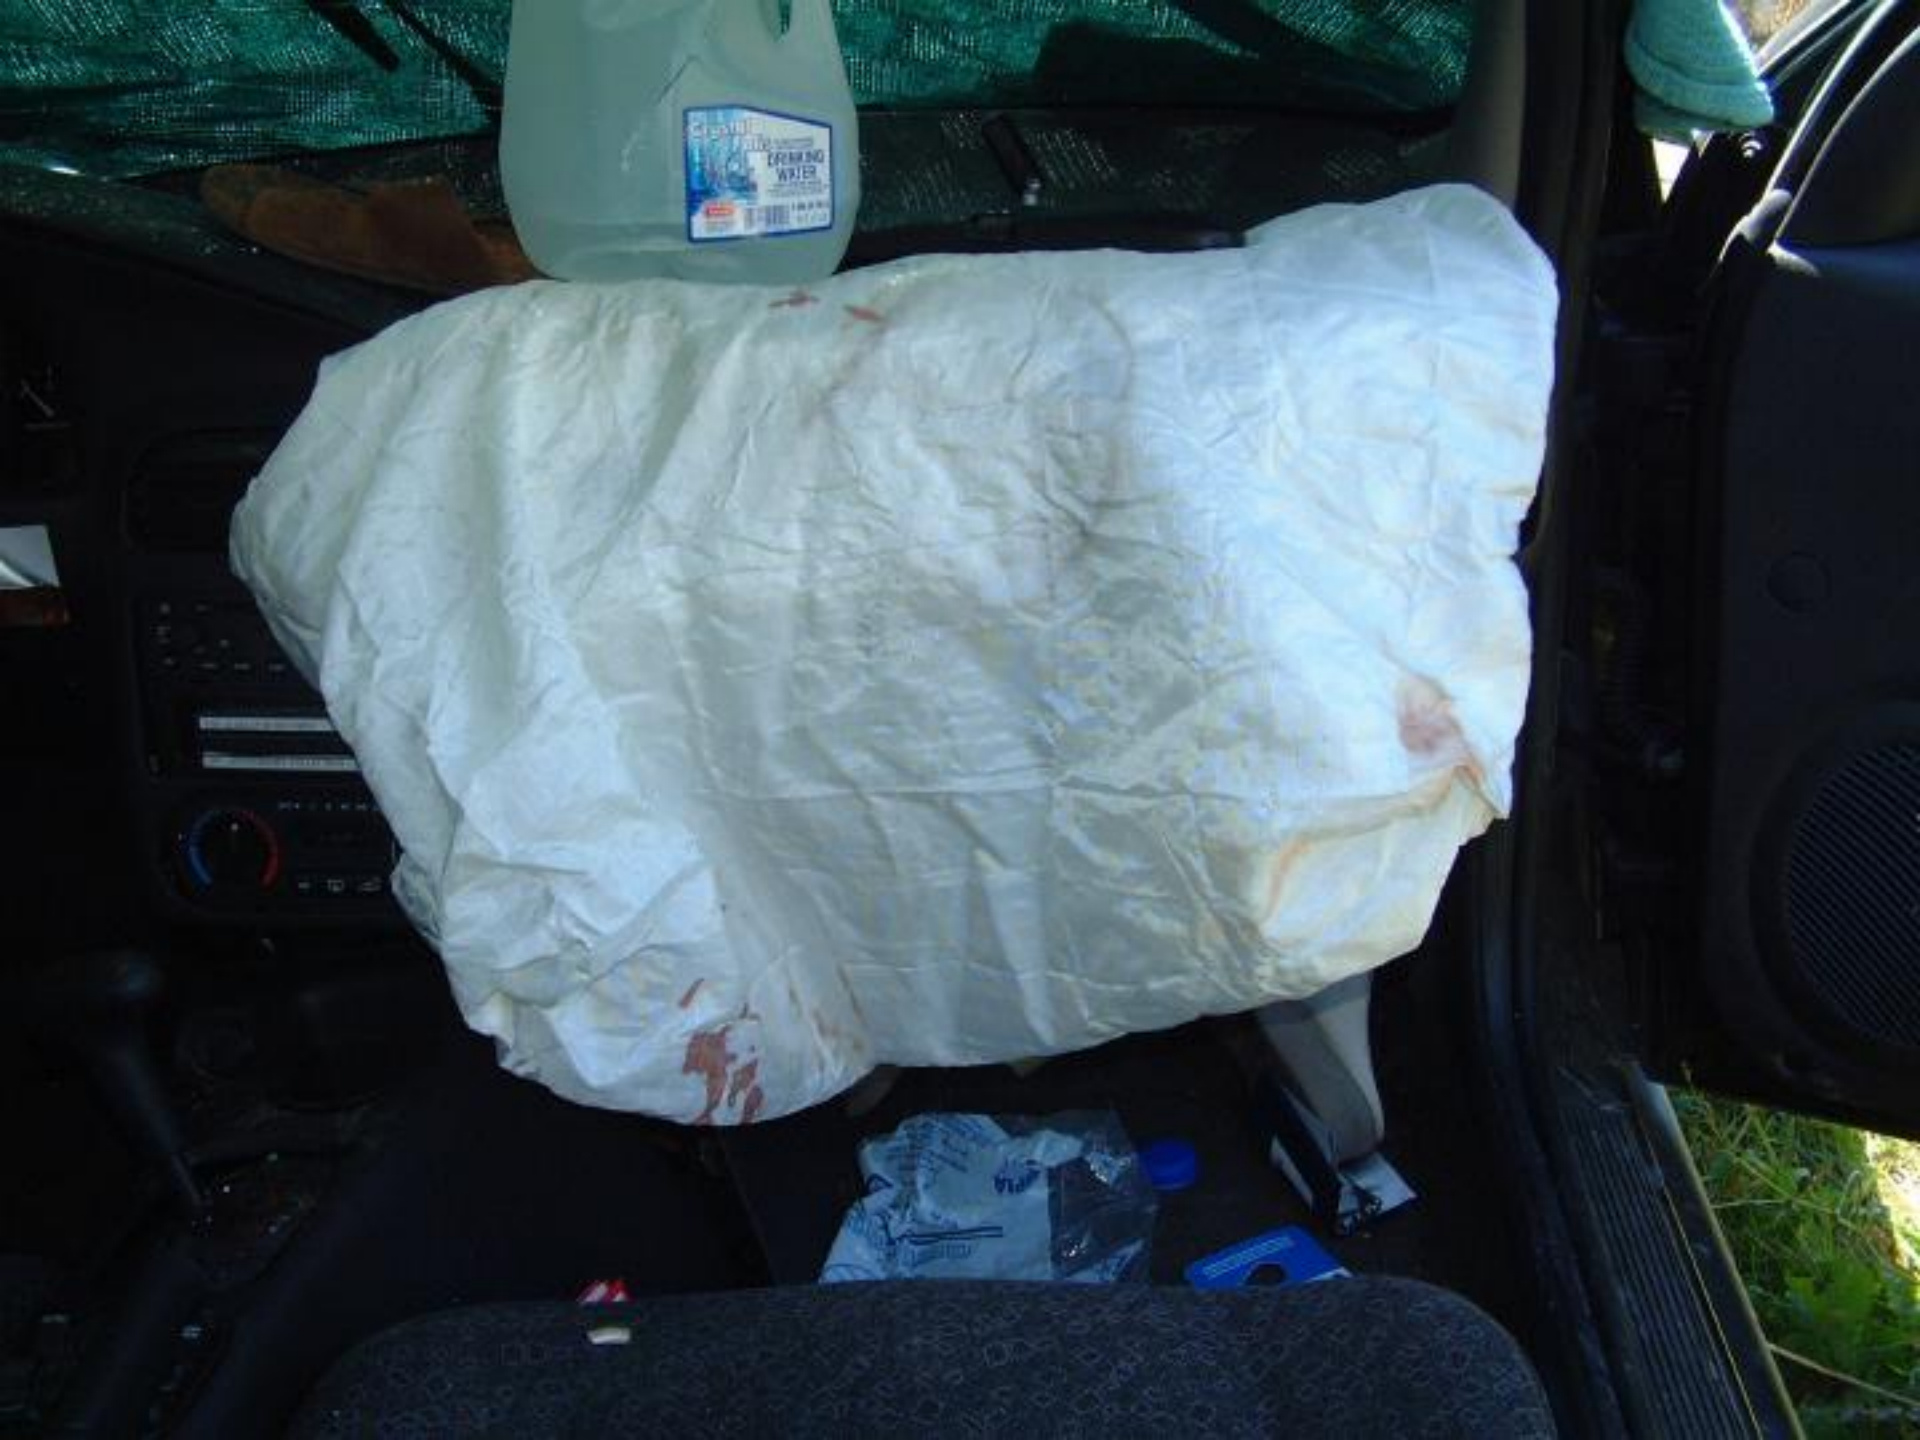
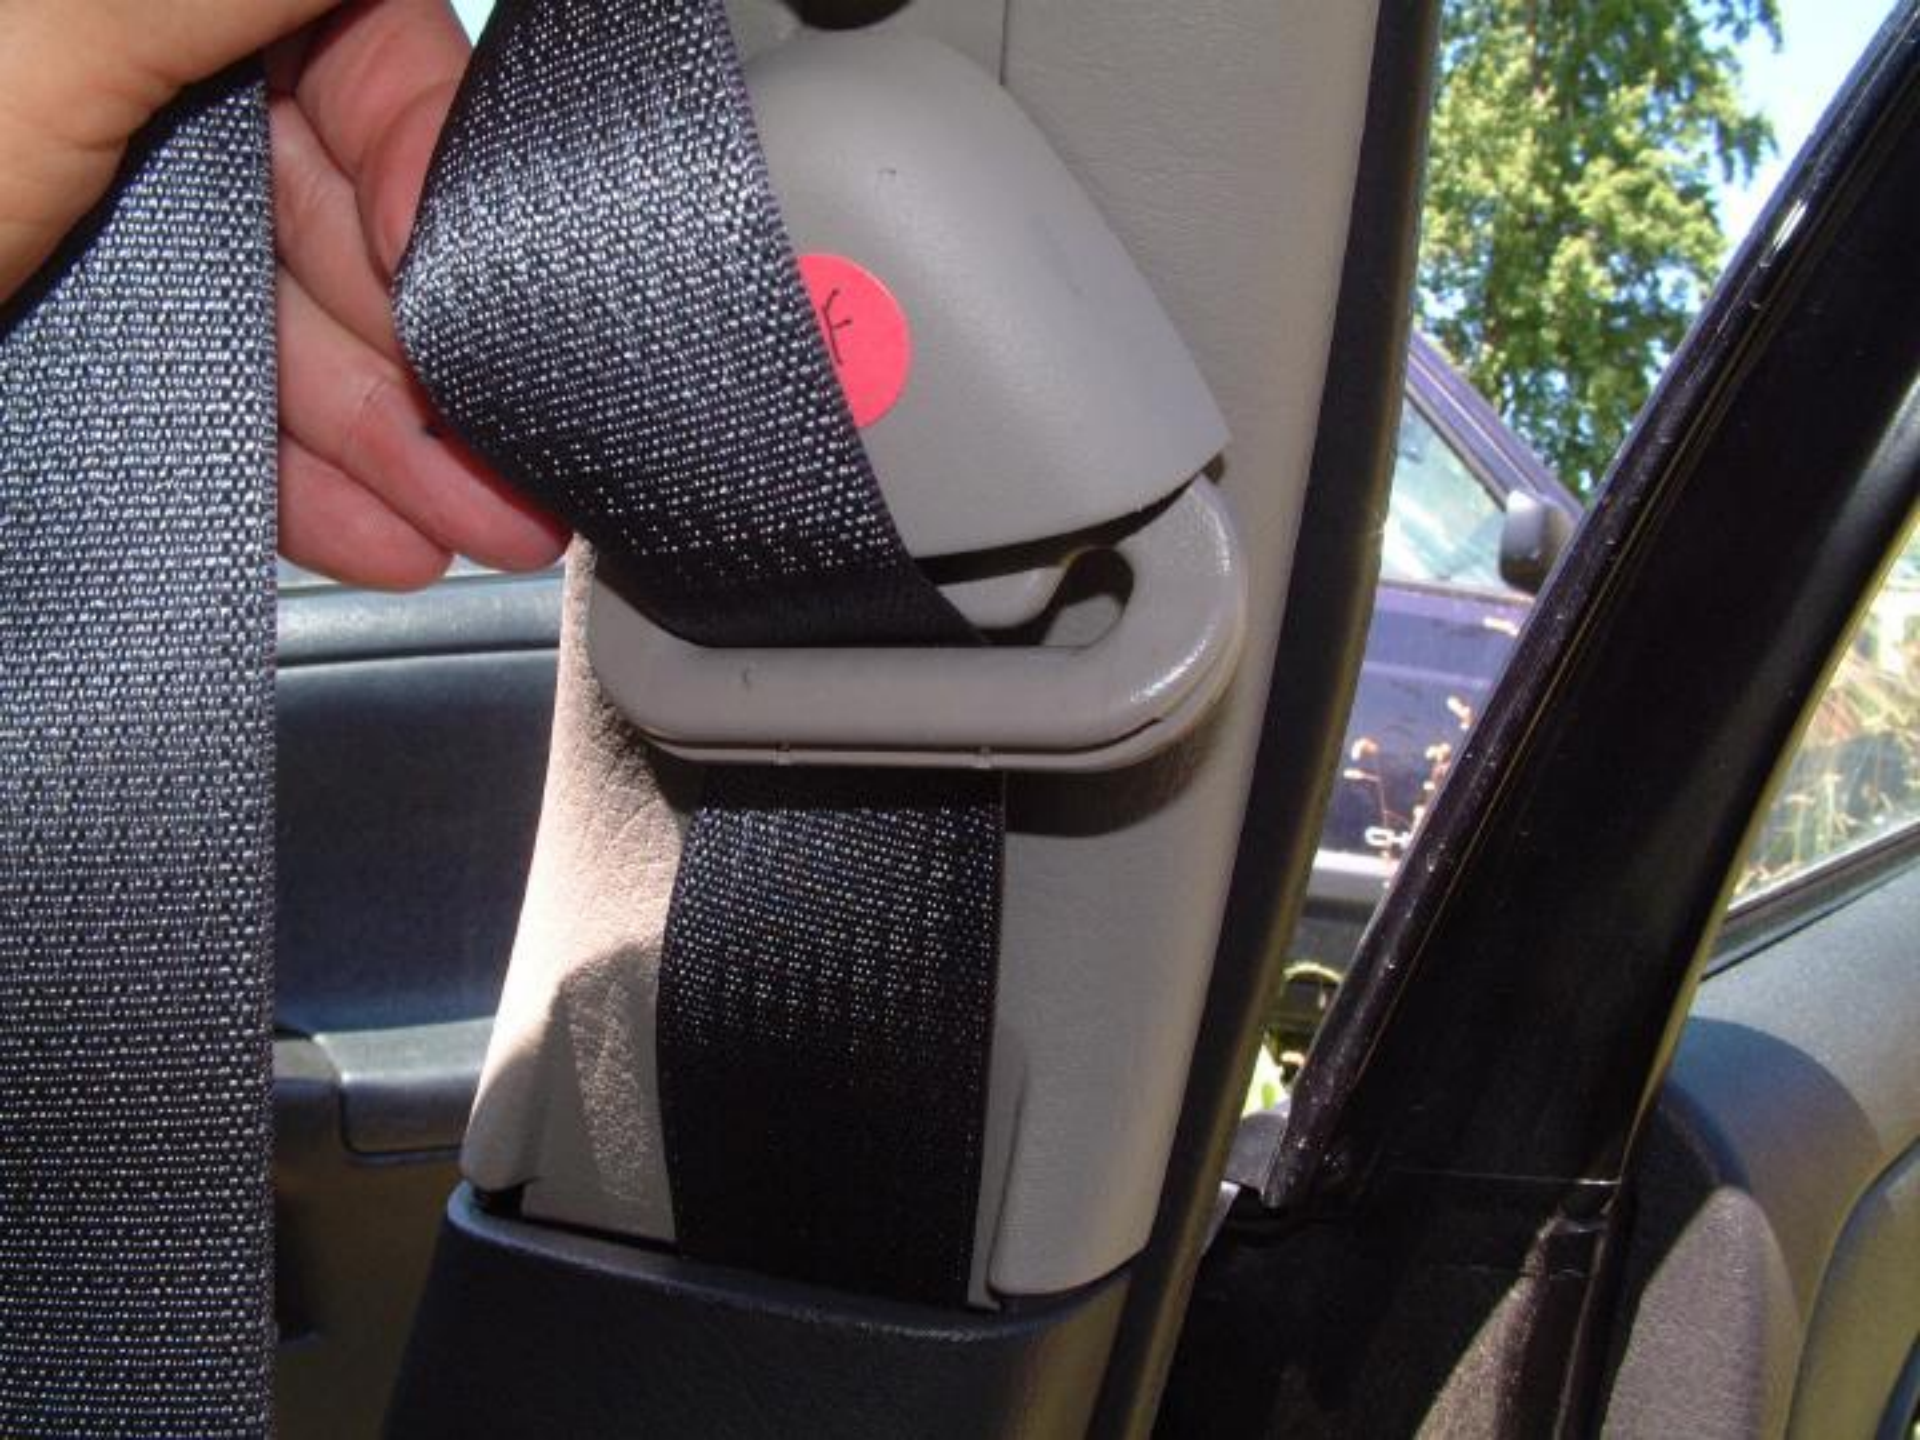
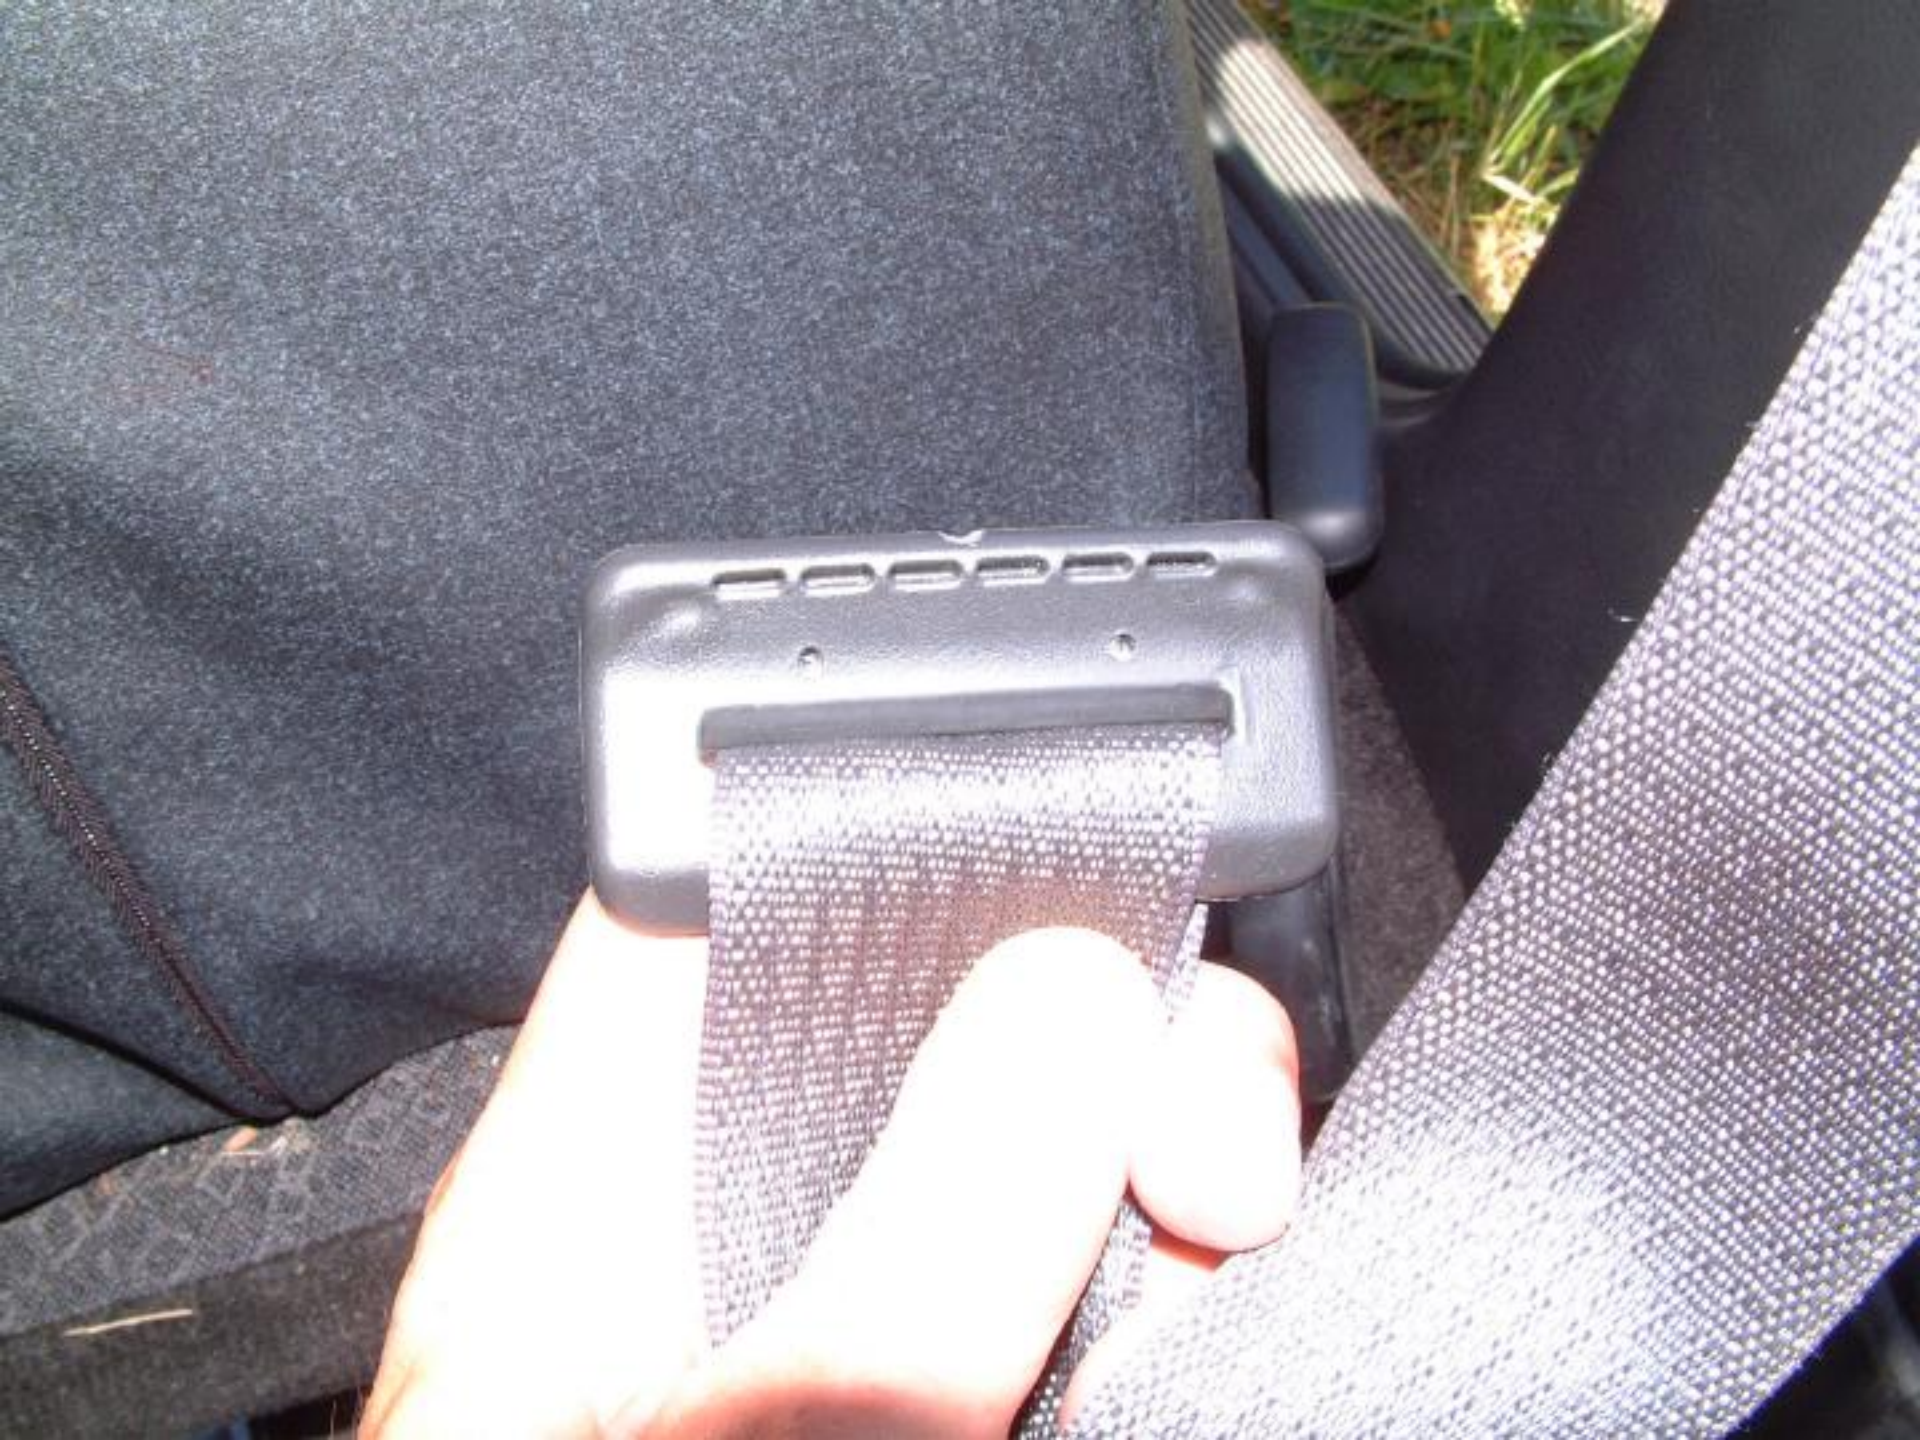
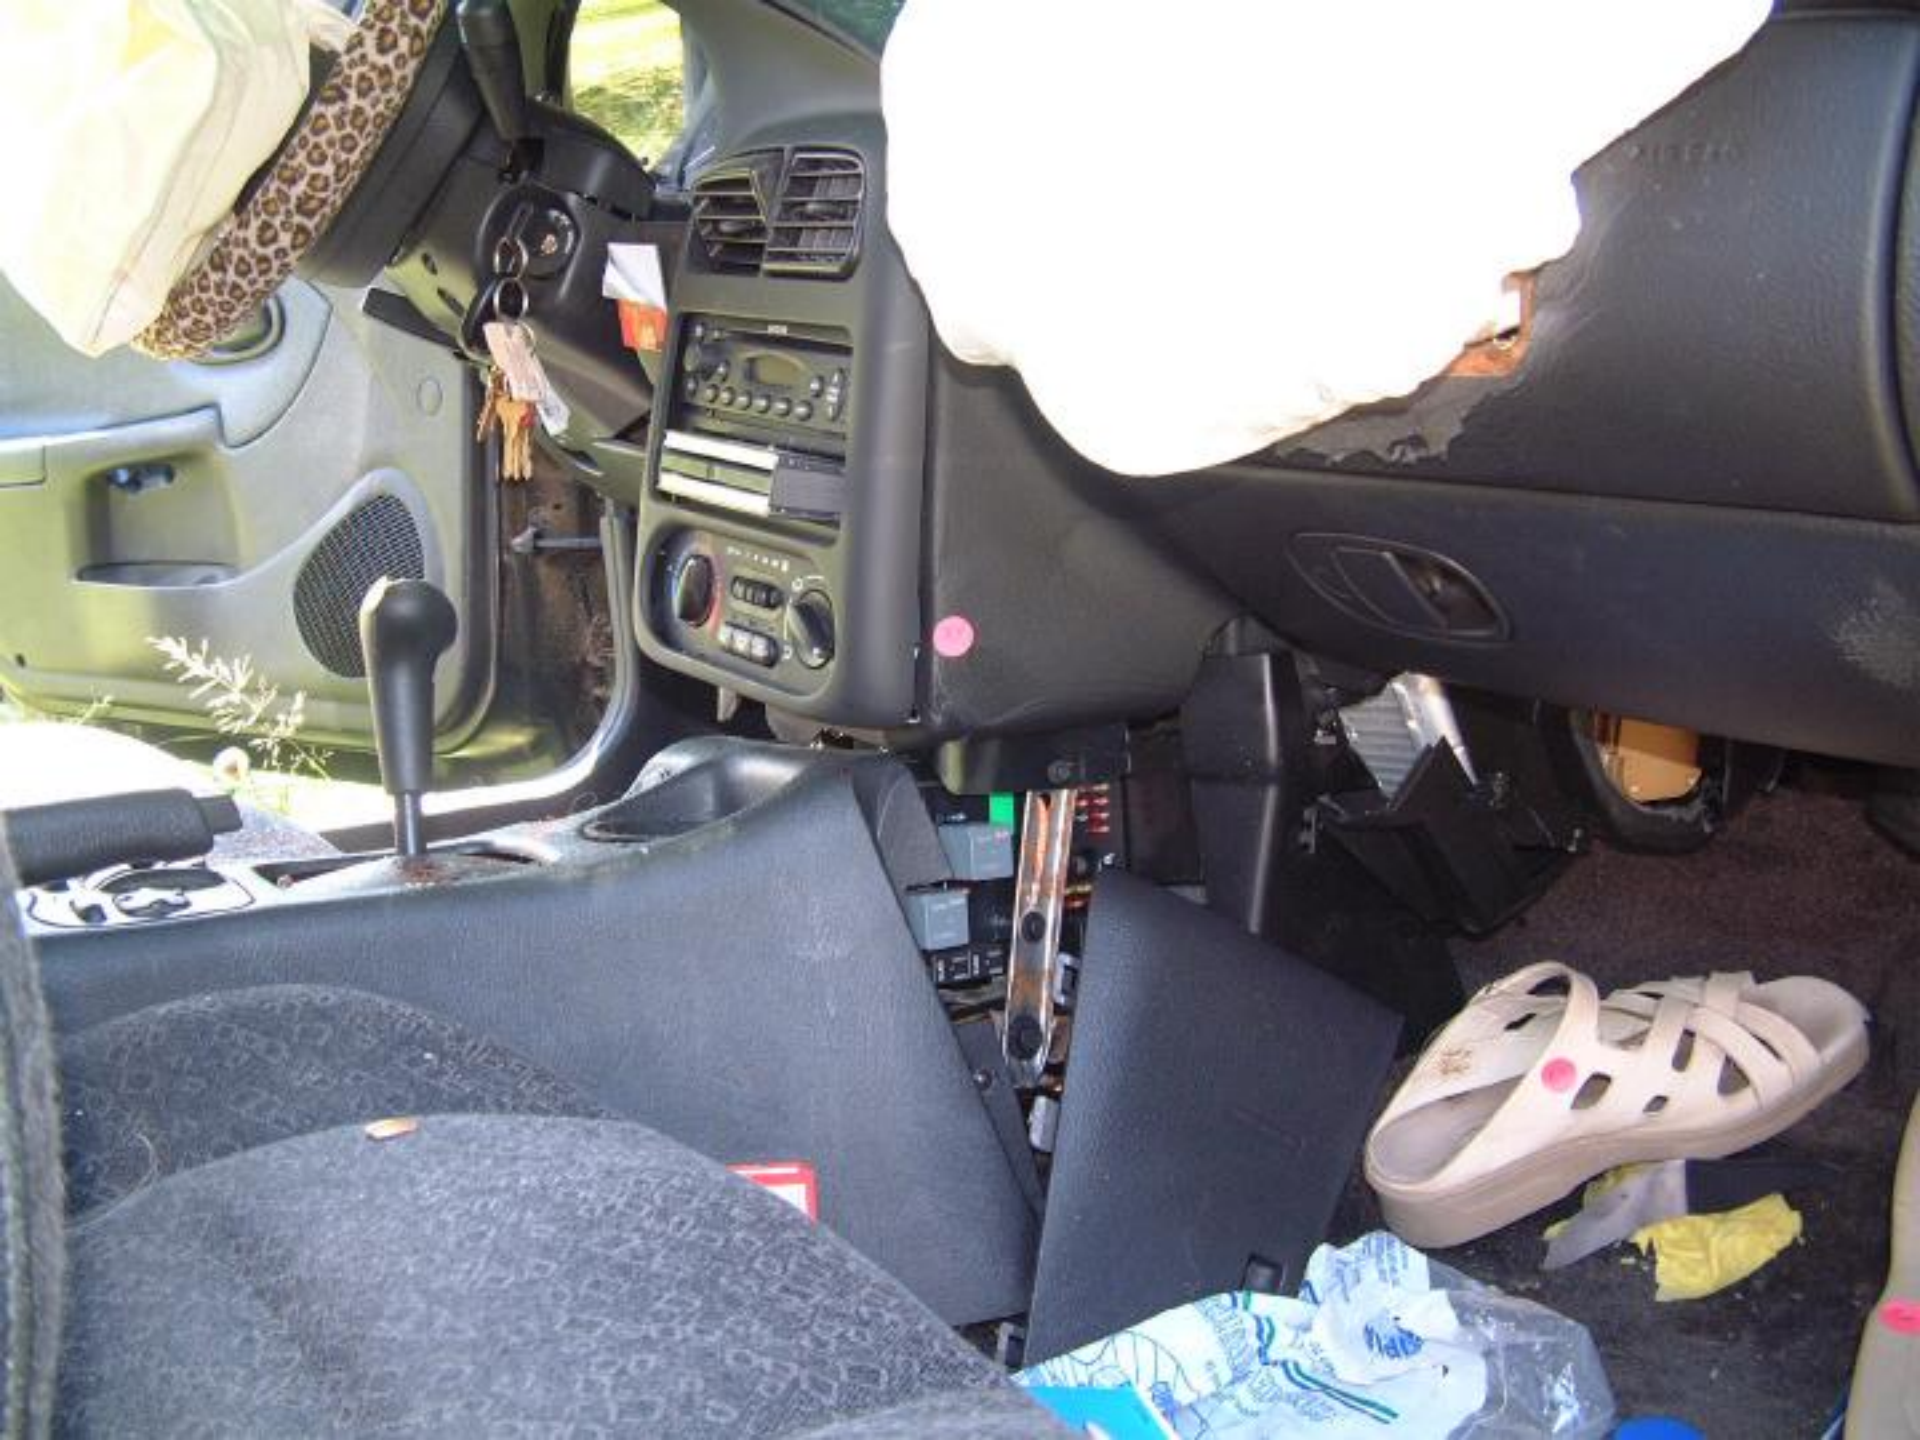
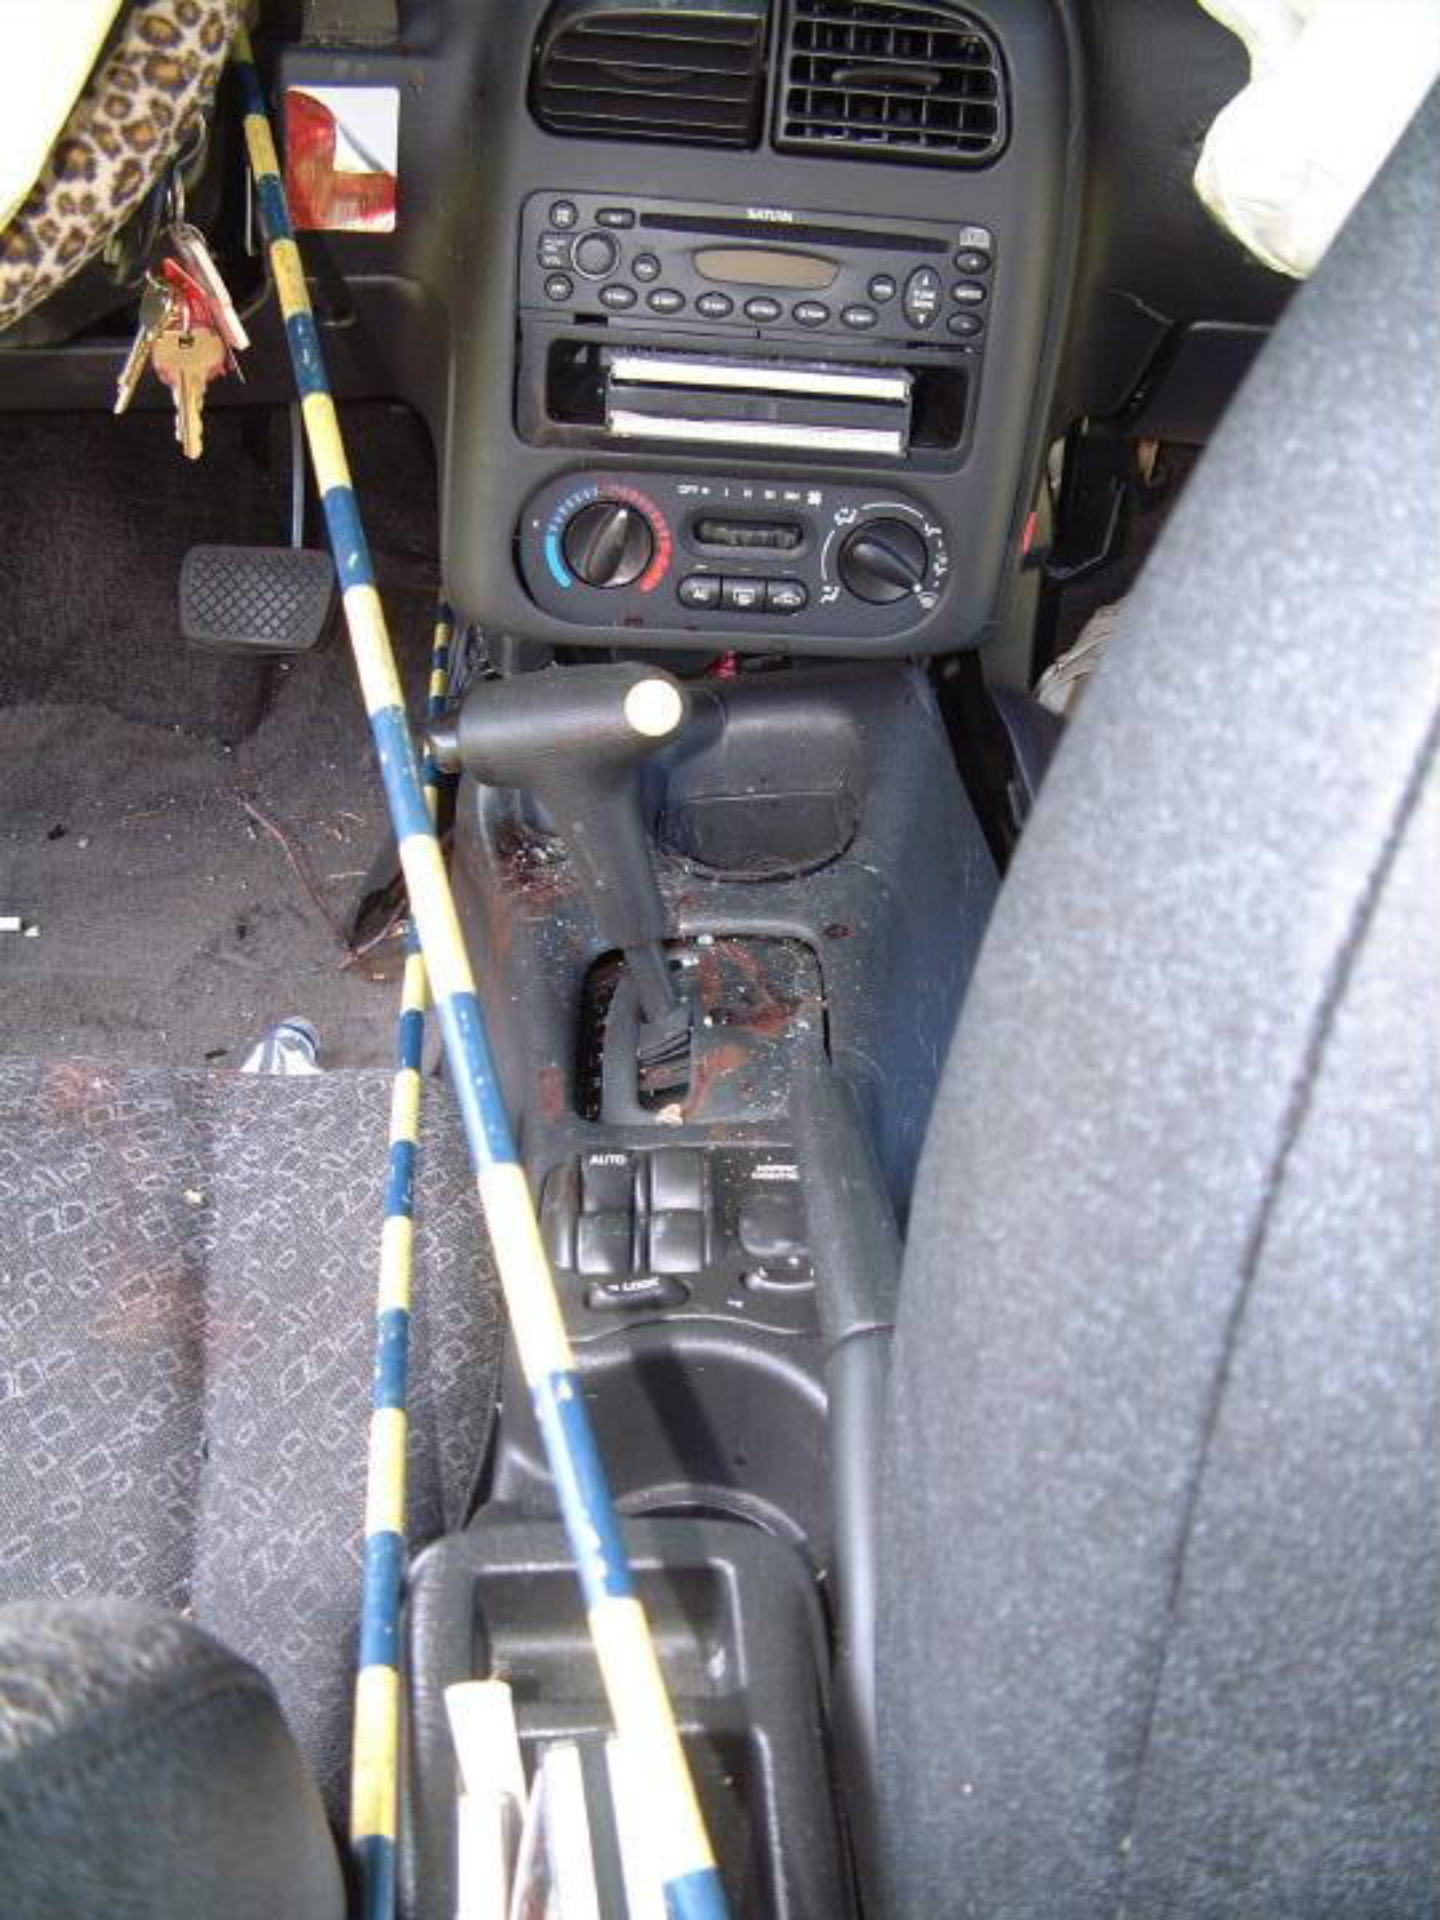
[77](#) The 5-ft, 3-in, 280-lb, 58-year-old female right-front passenger was **not** using the three-point belt, but [78](#) the frontal-impact airbag deployed. [79](#) There were no witness marks on the plastic D-ring or [80 81](#) continuous loop to indicate belt use at the time of the crash. The right-front seat was positioned in a rear-track position. On impact, the right-front passenger moved forward and to the left relative to the vehicle interior into the airbag, the vertical console, and glove compartment area, as evidenced by blood stains on the [82](#) passenger airbag fabric and [83](#) scuff marks on the vertical console and [84](#) glove-compartment door. She sustained bilateral periorbital contusions, a fractured nose, and contusions to the left breast and right side of the abdomen, possibly due to contact by the airbag. She sustained a fracture to the distal aspect of the left fifth metacarpal and a contusion to the dorsal aspect of the left hand from an undetermined source. She sustained a comminuted fracture with subluxation to the posterior column and dome of the left acetabulum, a fracture to the left patella, and a depressed fracture to the left tibial plateau, probably due to knee contact with the vertical console, [83](#) as evidenced by scuff marks and leftward displacement of the console. She sustained a contusion to the right knee due to contact with the glove compartment door, [84](#) as evidenced by the scuffmark on the glove-compartment door. She sustained a comminuted fracture to the distal

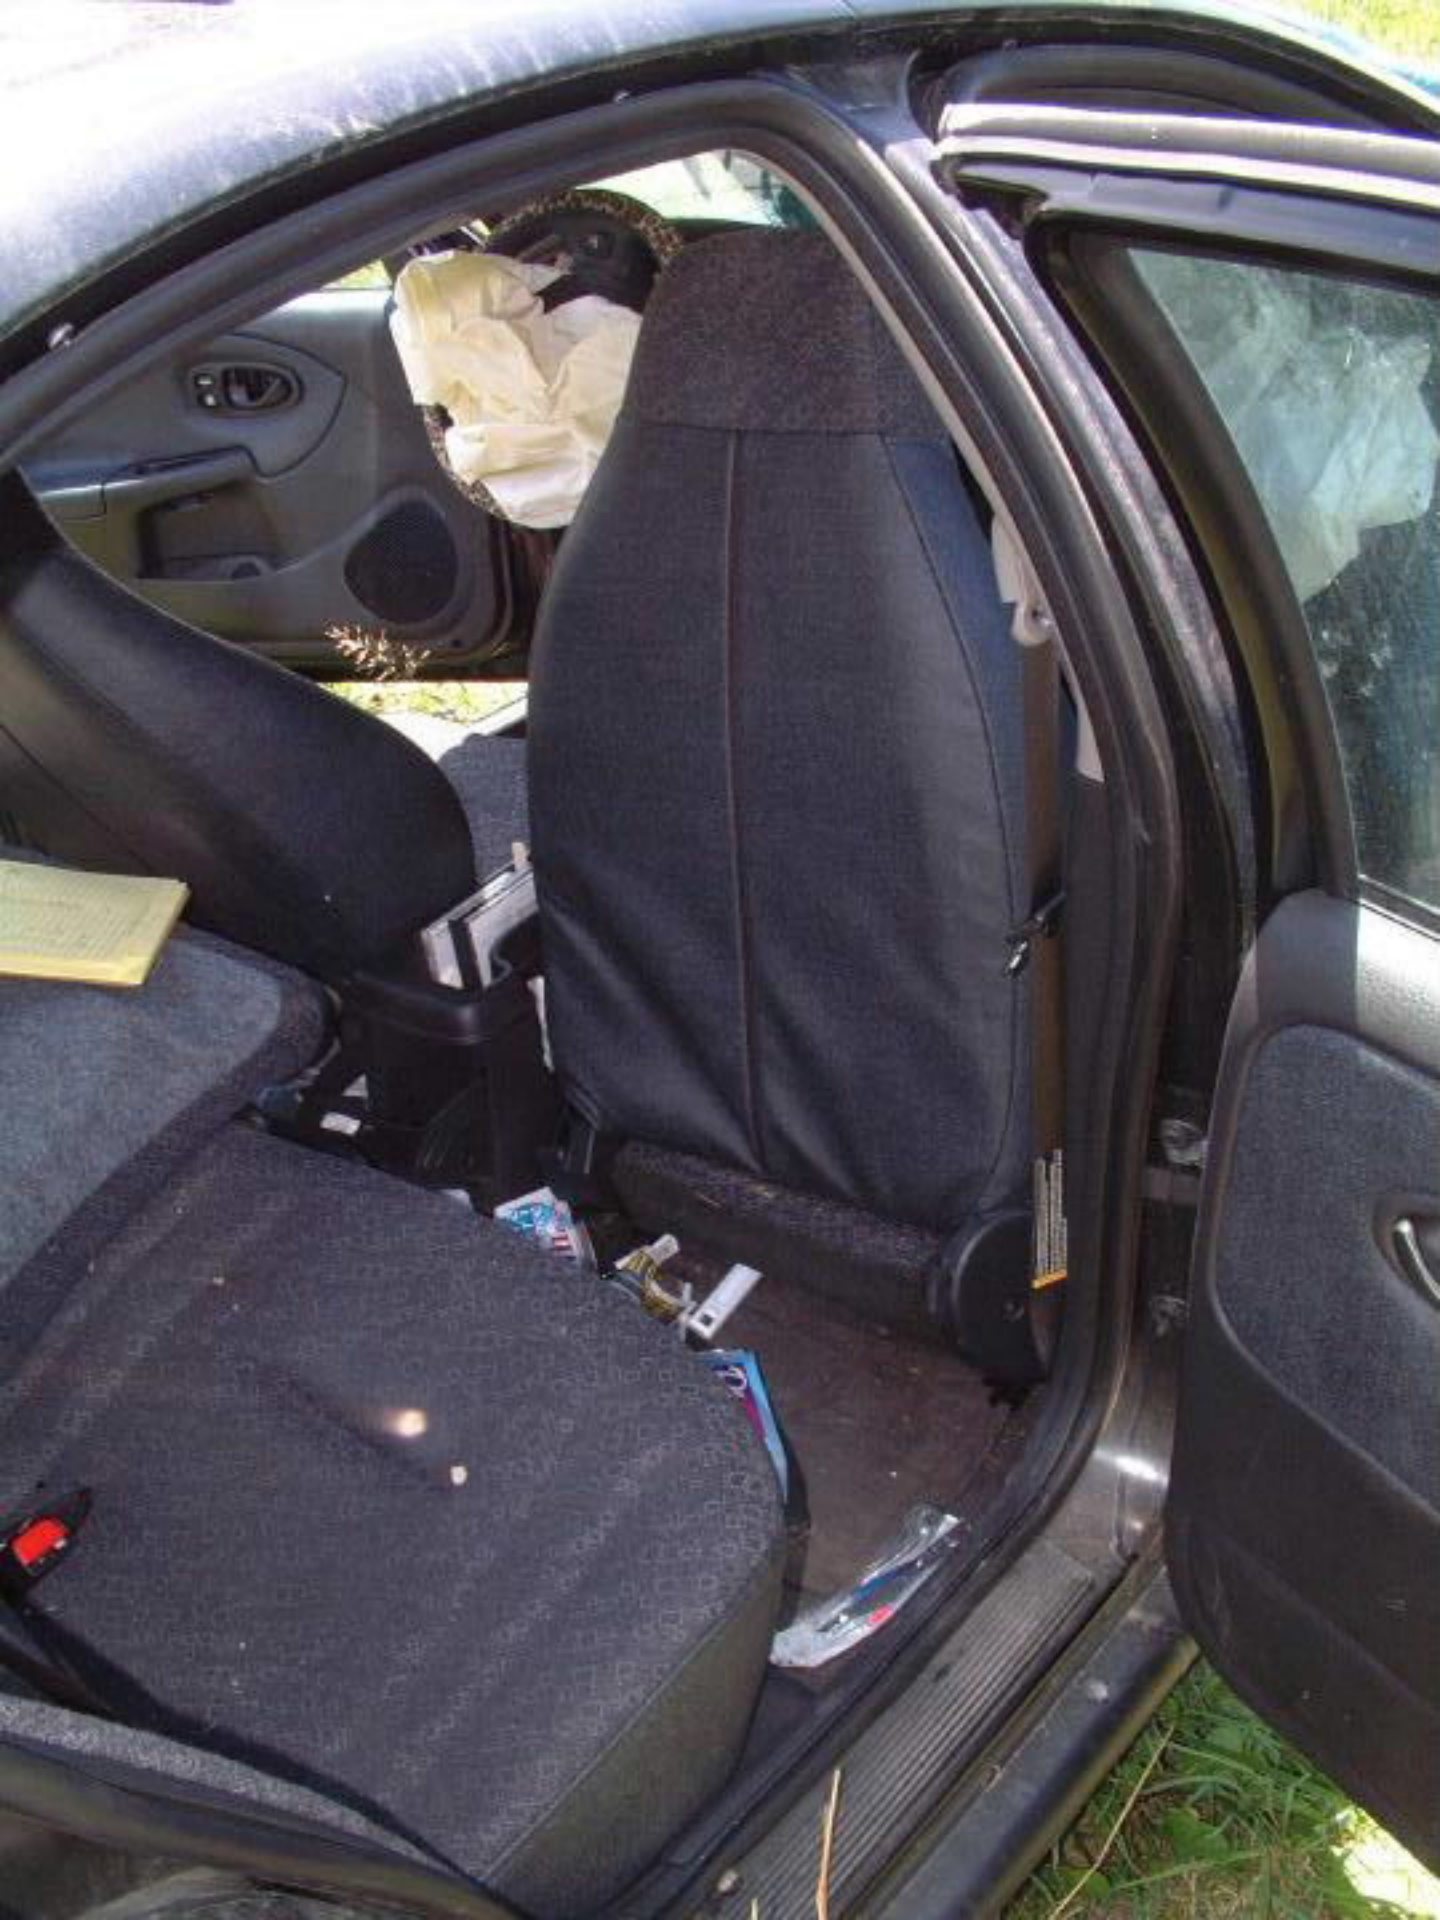
aspect of the right fibula with subluxation at the talus, and a fracture to the right talus, [85](#) probably due to contact with the toepan.
